# Seismic Evaluation

# Memorandum

**Re:** Facility Condition - Financial Impact - San Jose Med.Ctr.

This report summarizes the procedures and findings of the Senate Bill (SB) 1953 seismic evaluation of the Oaks Building at San Jose Medical Center located at 675 East Santa Clara Street, San Jose, California. The purpose of this study is to review the existing building conditions to determine the Structural Performance Category (SPC) and to identify existing SPC structural deficiencies. This report also seeks to inform HCA – The Healthcare Company and the hospital management about the likely impact of SB 1953 on system operations and potential use limitations at the San Jose Medical Center.

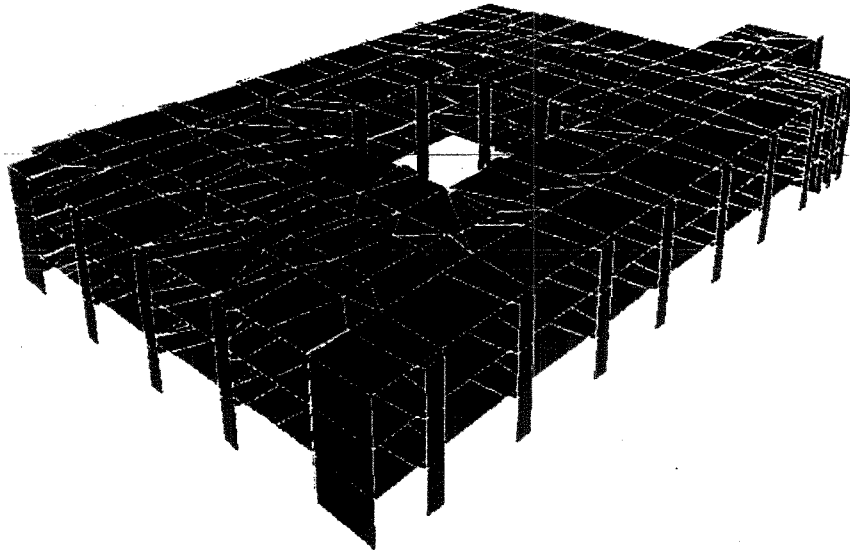
Figure 2-1: ETABS Model of the building

The ETABS model identified numerous walls that do not meet the requirements of the SB 1953 procedure with the revised seismic loads per Items 2 and 3 above. Further, Item 4 above cannot be mitigated without additional work to the building. The building is therefore categorized as **SPC 1**.

1. Material testing is required to verify the existing strength of shear walls.
2. A seismic hazards evaluation is required to address the site specific geotechnical hazards associated with the site.
